MARYLAND TRANSPORTATION AUTHORITY POLICE DEPARTMENT
COLLISION RECONSTRUCTION UNIT

Case # 13L007396

INFORMATION SHEET

CASE TYPE: Three vehicle collision involving one (1) Commercial Motor Vehicle with a Gross Vehicle Weight Rating of 80,000lbs (trailer empty) and two (2) passenger vehicles, resulting in one (1) passenger vehicle going over the wall into the Chesapeake Bay.

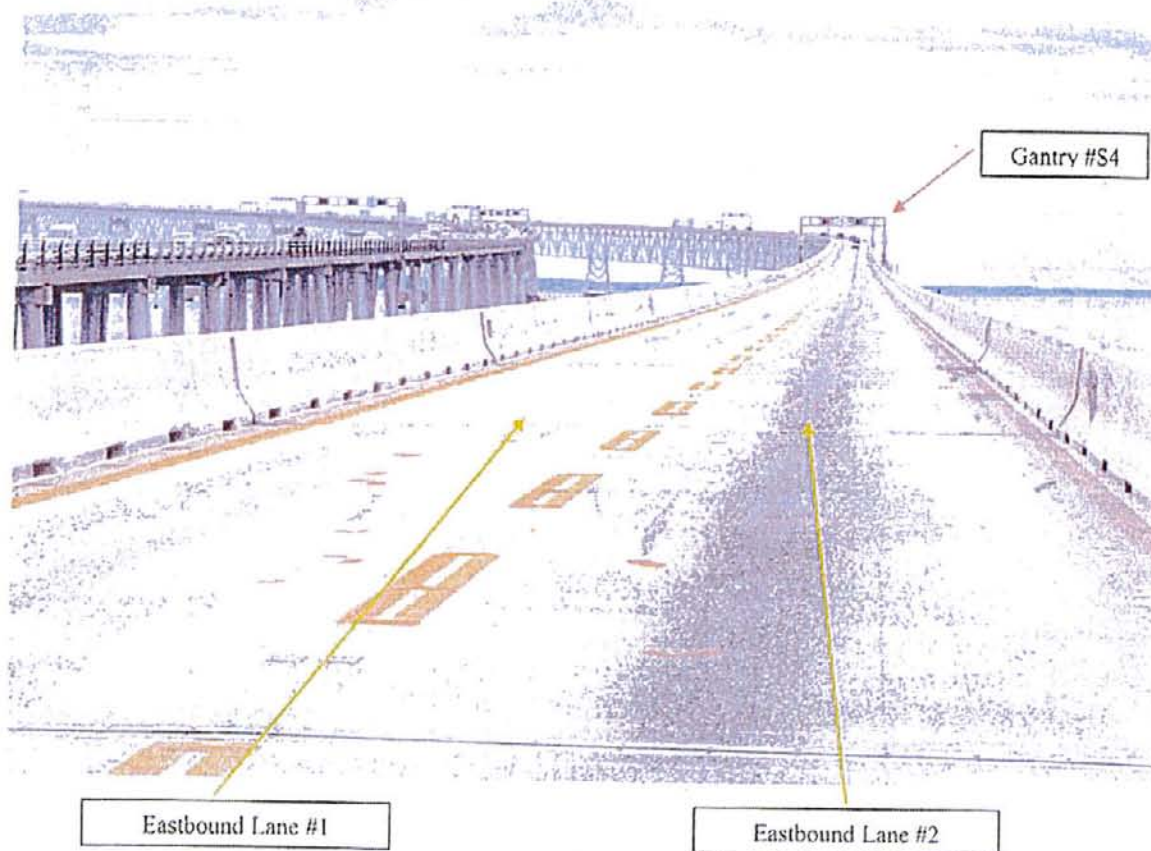
The below photograph was taken just prior to and underneath gantry #S3 facing eastbound towards gantry #S4

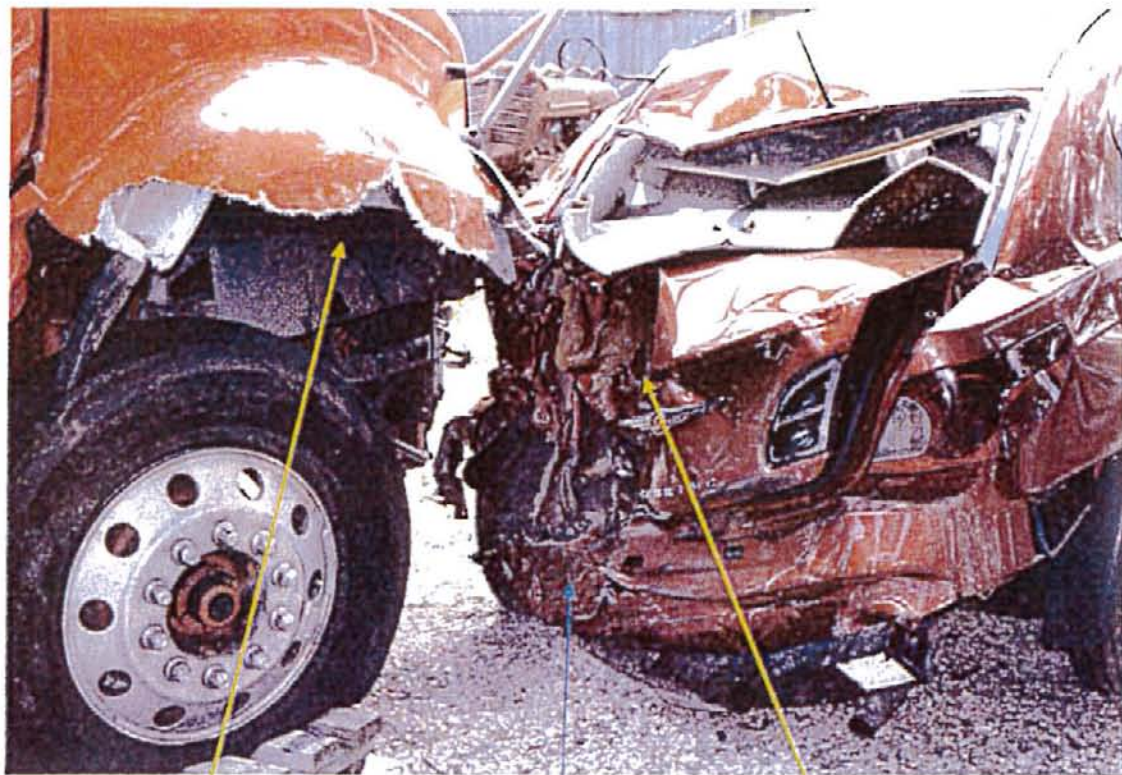
Vehicle #1's front right bumper and fender engaged the rear of Vehicle #2 just left of center in the area of the bumper and trunk.

The photograph below depicts the first impact from Vehicle #1 into the rear of Vehicle #2.

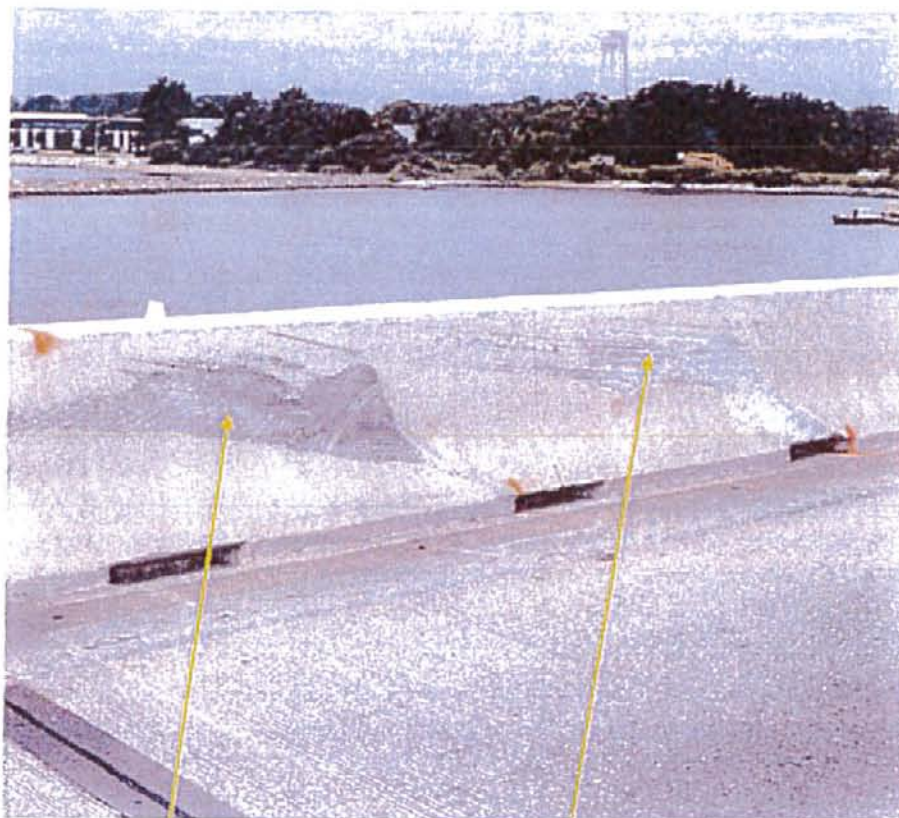
The photograph below indicates where Vehicle #2 made contact with parapet wall.

Vehicle #2's impact with the
parapet wall

The damage present here on the parapet
wall is from a previous crash

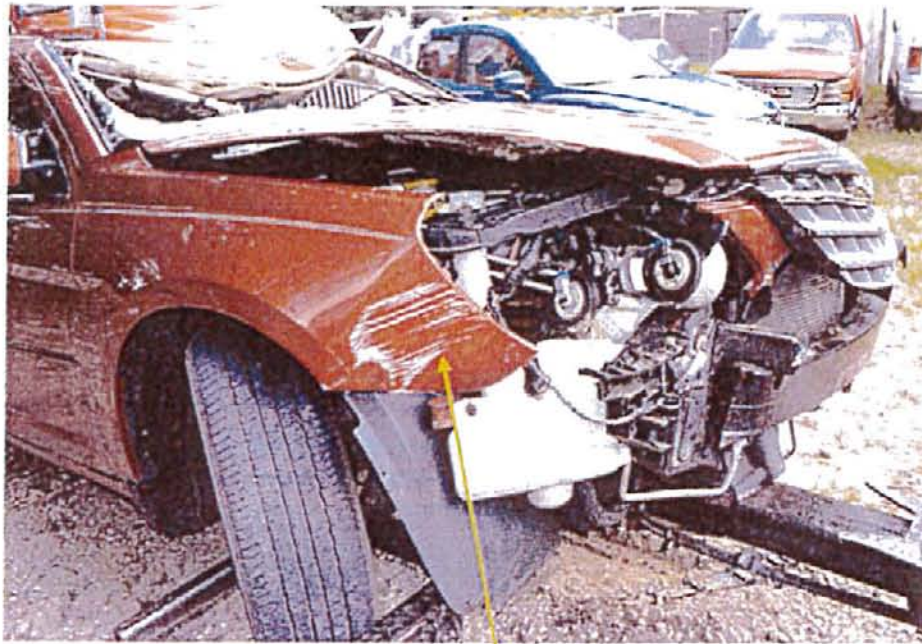
The photograph below indicates where Vehicle #2 made contact with the parapet wall.

This shows Vehicle #1's
initial impact with the
right side parapet wall.

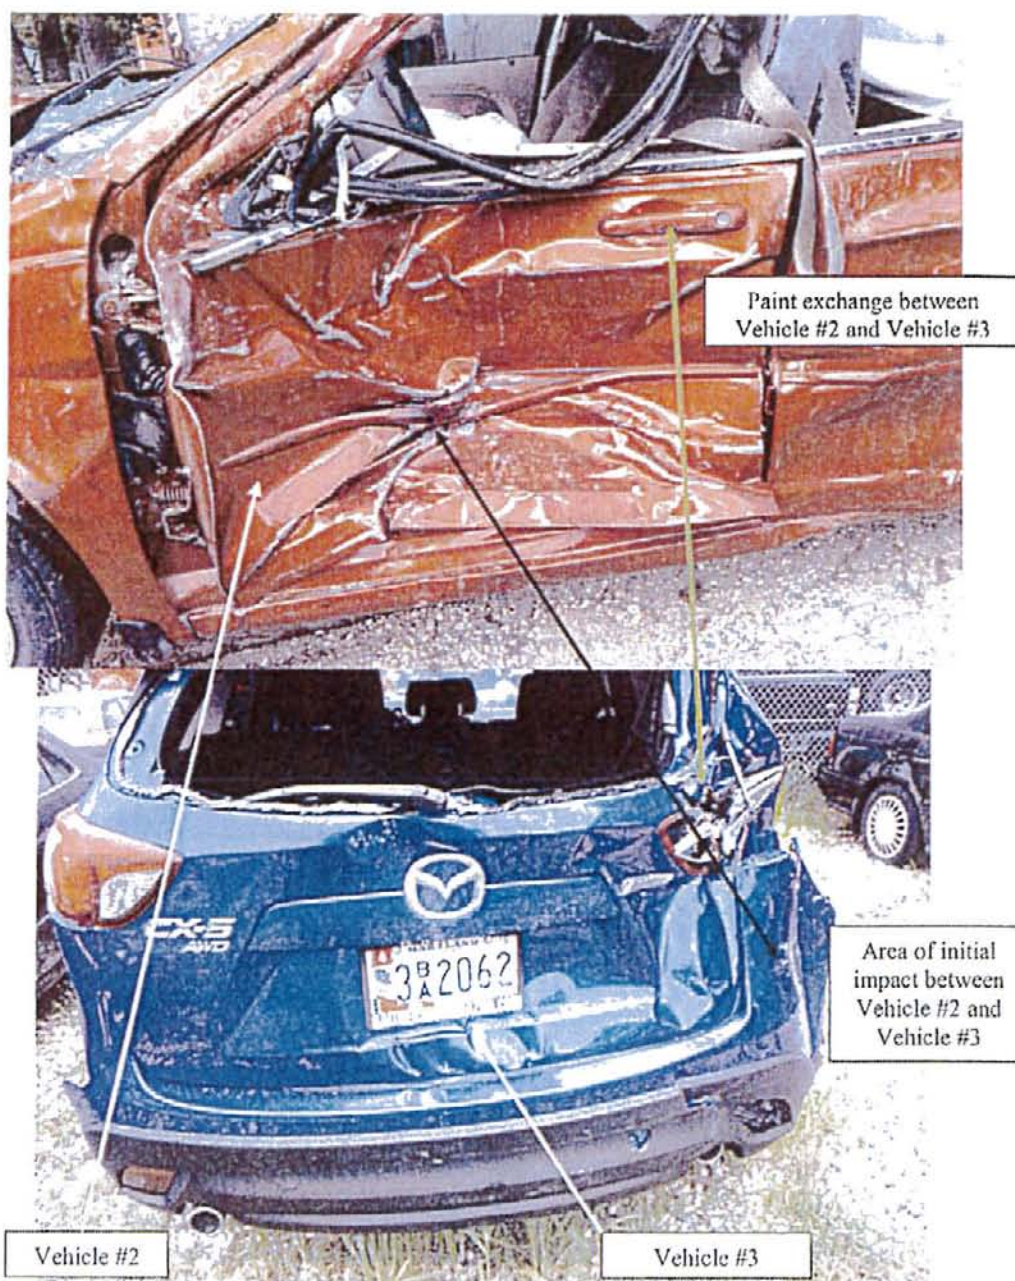
The photograph below indicates where Vehicle #2's driver's side front door made contact with the rear of Vehicle #3.

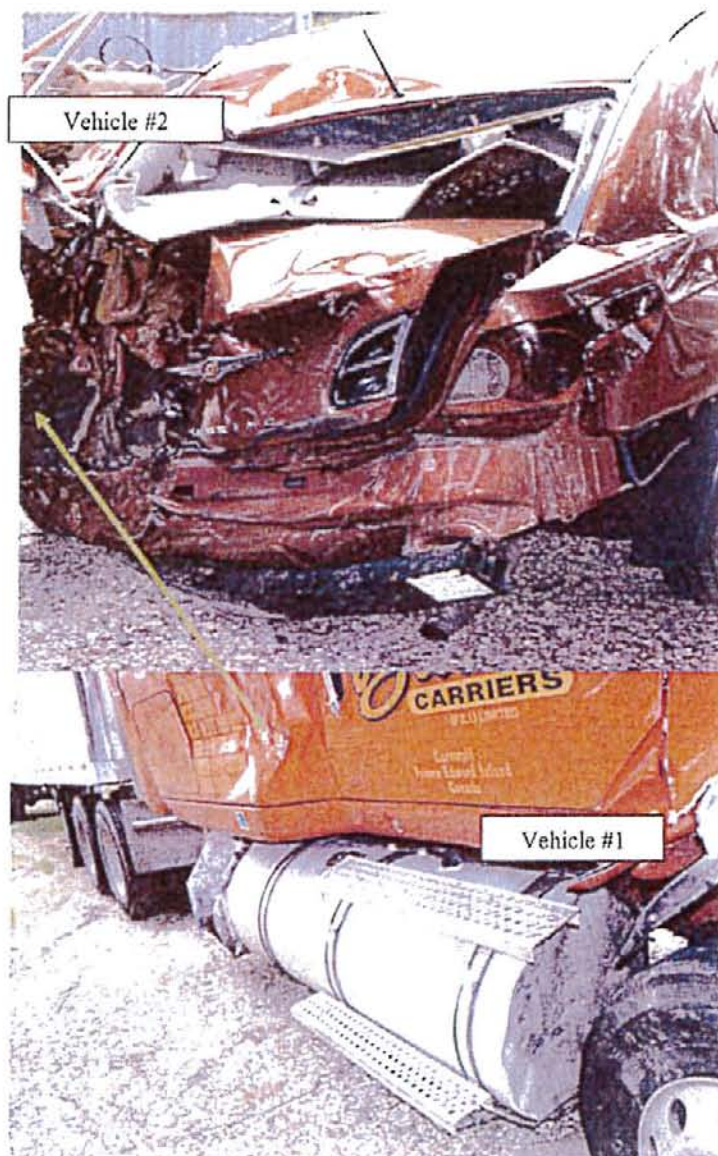
The photograph below indicates where Vehicle #1's passenger side sleeper berth struck Vehicle #2 in the left rear while Vehicle #2 was on the parapet wall.

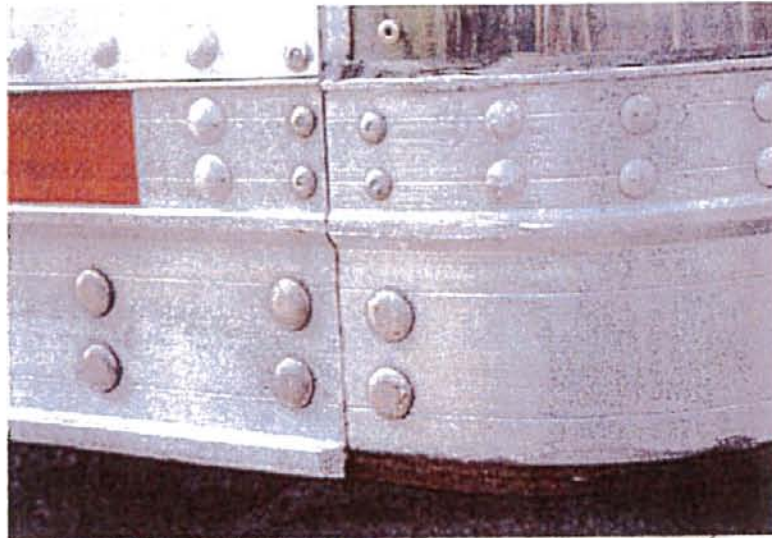
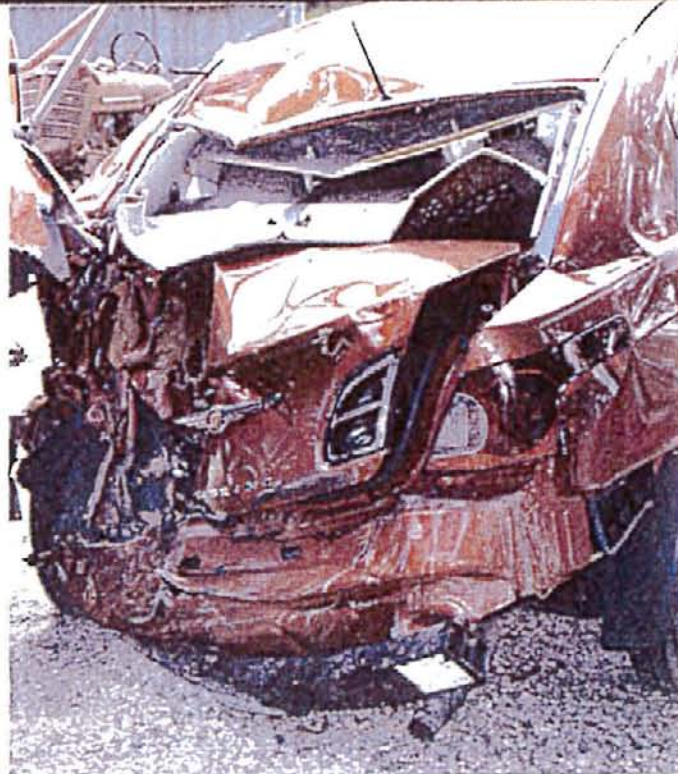
The above photograph shows the last impact between Vehicle #1's trailer and Vehicle #2. Vehicle #1's trailer struck the rear of Vehicle #2 at an undetermined location. (The location was undetermined due to the extensive damage done to the rear of Vehicle #2)

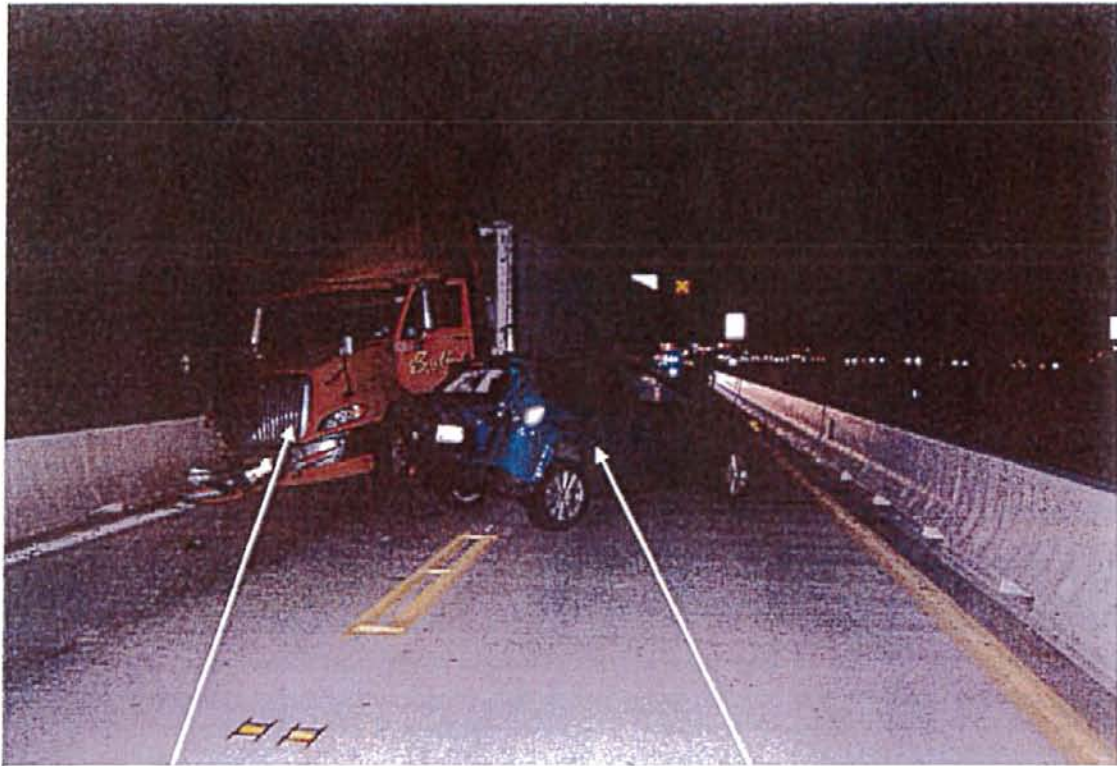
Final Rest of Vehicle #1 and Vehicle #3

Vehicle #1's Final Rest

Vehicle #3 Final Rest
